VEHICULAR IMPACT TESTS OF A
TRUCK MOUNTED ATTENUATOR
CONTAINING VERMICULITE
CONCRETE CELLS

1. REPORT NO. FHWA/CA/TL-80/26		2. GOVERNMENT ACCESSION NO.		3. RECIPIENT'S CATALOG NO.	
4. TITLE AND SUBTITLE VEHICULAR IMPACT TESTS OF A TRUCK MOUNTED ATTENUATOR CONTAINING VERMICULITE CONCRETE CELLS				5. REPORT DATE June 1980

16. ABSTRACT Six vehicular impact tests were conducted. Cars ranging in weight from 1890 lbs to 4480 lbs impacted the rear end of dump trucks at speeds of 45 mph. In five of the tests truck mounted attenuators (TMA's) were used on the trucks. The TMA tested was a 6 ft-0 in. long by 8 ft-0 in. wide by 2 ft-0 in. high plywood box enclosing 84 crushable vermiculite concrete cells arranged in a designed pattern. The tests were intended to study 1) the effectiveness of the TMA in reducing car and truck damage and decelerations, 2) the vehicle trajectories after impact and specifically the roll ahead distance of the trucks using different truck braking conditions, and 3) other characteristics of the TMA's such as ease of use, amount of debris after impacts, durability, etc. It was concluded that the TMA was quite helpful in reducing vehicle damage and decelerations for l

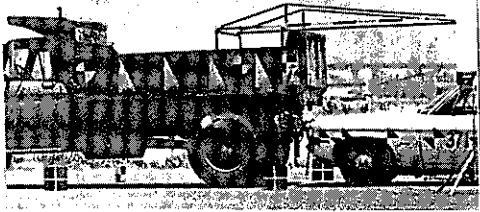
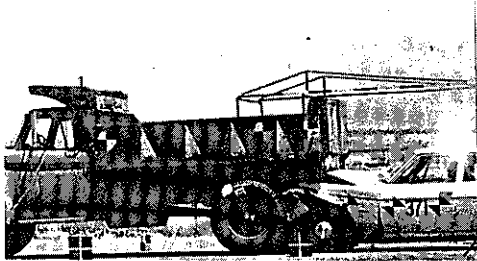
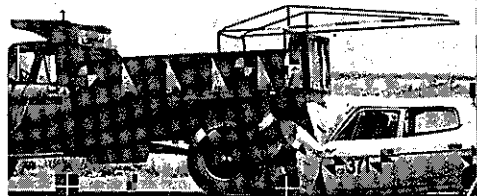
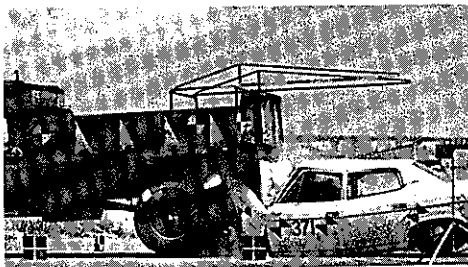
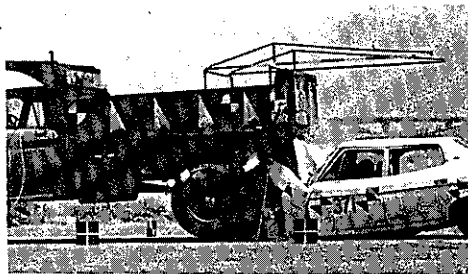
The car struck the truck at the intended speed and angle. The car was 9 inches off center to the left of the truck centerline. The front of the car was severely crushed and compressed against the undercarriage of the truck before the truck began to move. Initially, after impact, the truck bed was forced upward and the rear wheels were lifted a few inches off the ground as the truck moved forward. During this time, the rear wheels did not turn until they made contact with the ground again. The rear wheels rotated 88°. The front wheels on the truck rotated during the entire forward movement of the truck, a total of over 180°. After the maximum compression of the front end of the car occurred, the car appeared to re-extend slightly due to the storage of elastic energy. However, the car

Max. Car Pass.Compart.Decel.Dist.,s 13.9 ft
Truck Roll Ahead Distance 10.3 ft
Max. Pitch, Car (Rear End)* -8.0°
Max. Rise, Truck Dump Body Rear 10.0 in.
TAD/VDI Index, Car FD-7/12FDEW6

*Pitch was less at the front end because the car buckled in the middle.

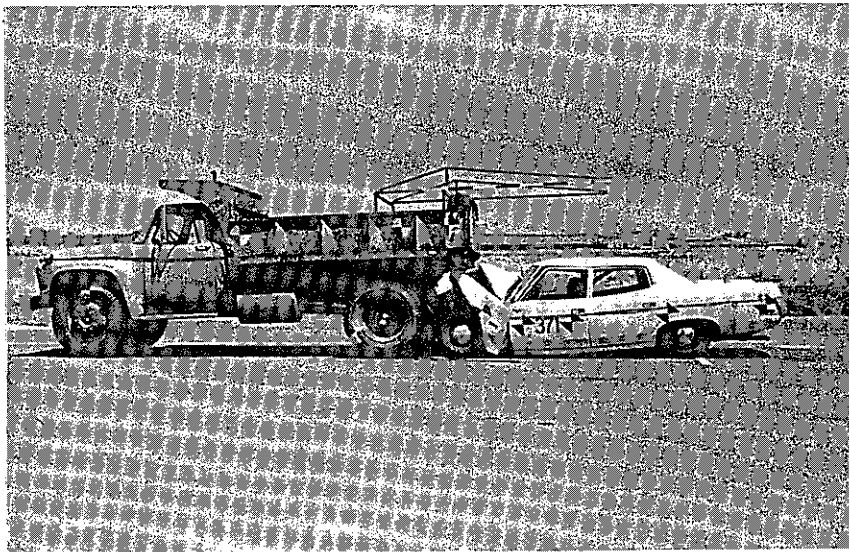
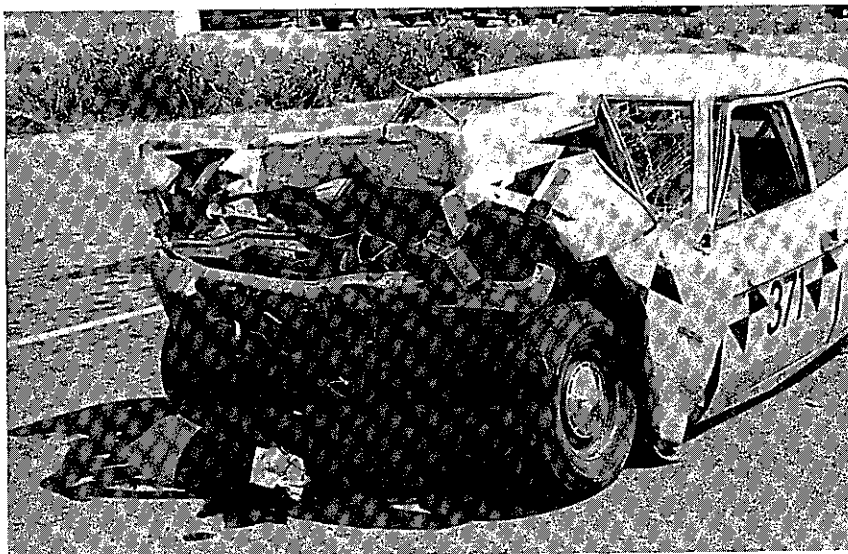
Figure 8.

Test Vehicles
After Impact

Pintle Hook at Rear
End of Truck

was hooked onto the truck and traveled with it to a stop. The truck moved forward a total of 10 ft 4 in. There was minimal yawing and pitching of the car during impact.

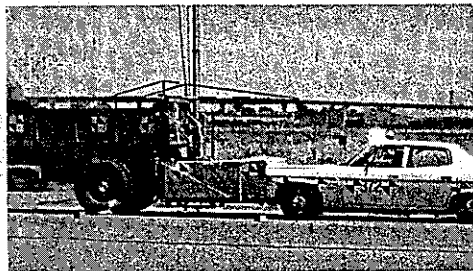
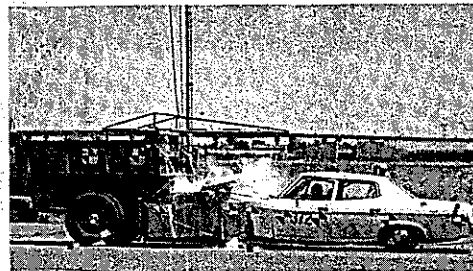
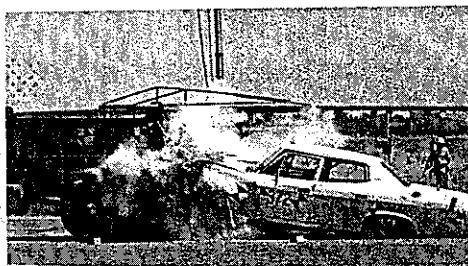
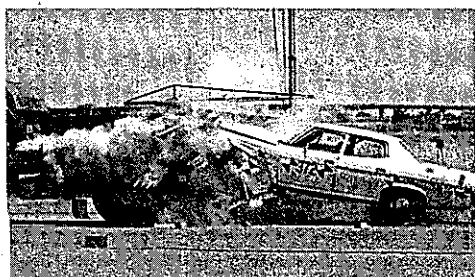
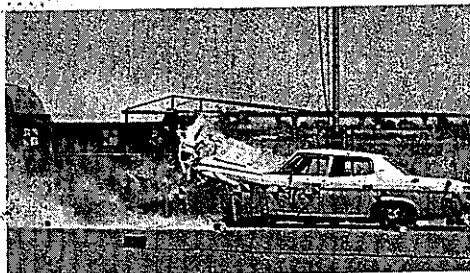
Figure 9. Data Summary Sheet - Test 372

The car crushed through practically the entire 6 ft 0 in. length of the TMA before the truck began to move. Ultimately,

Max. Car Pass.Compart.Decel.Dist.,s	13.9 ft
Truck Roll Ahead Distance	7.9 ft
Max. Pitch, Car	-10.0°
Max. Rise, Truck Dump Body Rear	5.7 in.
TAD/VDI Index, Car	FD-5/12FDEW5

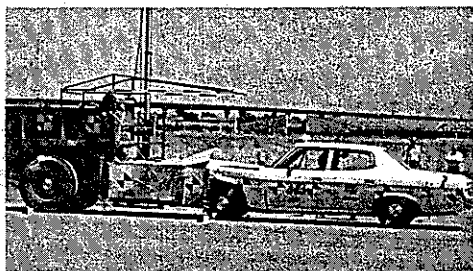
Figure 12. Data Summary Sheet - Test 373

The passenger compartment of the car moved roughly 6 ft 0 in. ahead after initial impact with the TMA, while the truck only moved a few inches during attenuator penetration. The final roll ahead distance for the truck was 13 ft 10 in.

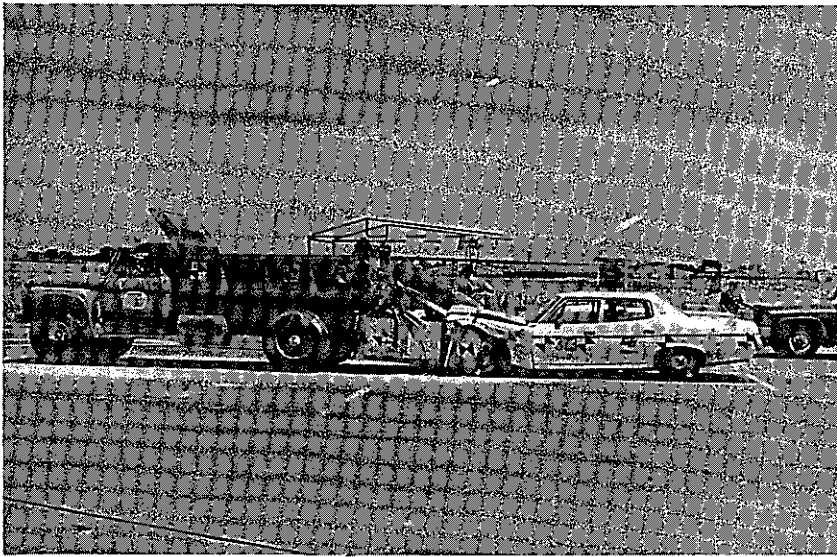
Figure 13.

Test Vehicles and
TMA After Impact

Damage to the car was severe but less than in Test 372 and much less than in Test 371. The front end was uniformly crushed back a maximum of 9 inches at a height of 24 inches above ground. The hood was crushed back a maximum distance of 11 inches at a height of 44 inches above ground.

not move back, the windshield was cracked, all four doors were jammed, and the roof over the door posts on the left side was crimped slightly. The tires were all intact. The car could not be driven but it did roll because the front wheels were not disabled. There was no intrusion of vehicle parts or barrier components into the passenger compartment.

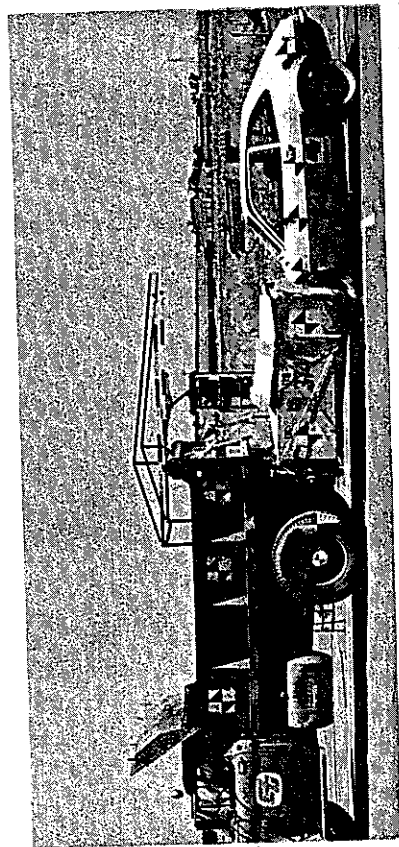
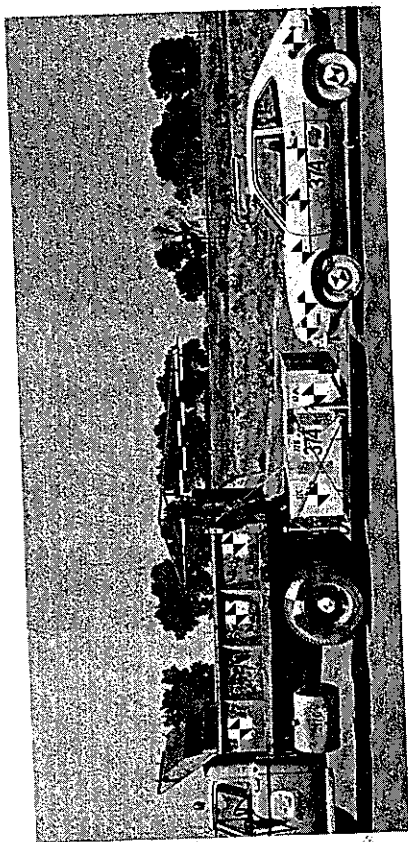
Figure 15. Test 374. Test Vehicles and TMA Before and After Impact

Damage to the car was quite severe. The front end was crushed back a maximum of 22 inches (about 12 inches at the centerline) at a height of 28 inches above ground.

Only part of the energy absorbing capacity of the TMA was used up. The cell-filled box had a permanent maximum crush that varied from 30 inches at the top to 39 inches at the bottom. The steel grid work supporting the box had a permanent maximum crush of 11 inches. The front steel bar of this gridwork had two semi-circular indentations where the car wheels had bent it. There was a small amount of debris from the TMA scattered around the impact area. There was no damage to the TMA controls on the truck or the TMA steel plate backup structure.

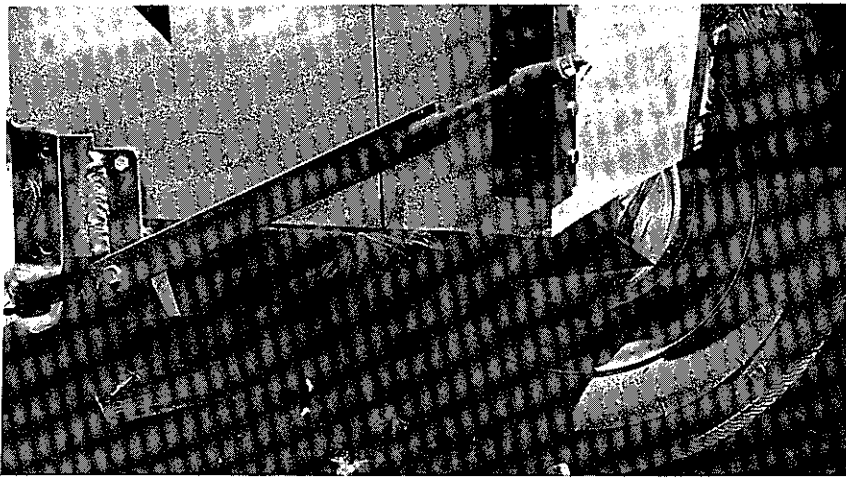
Figure 16.

Test Car Damage

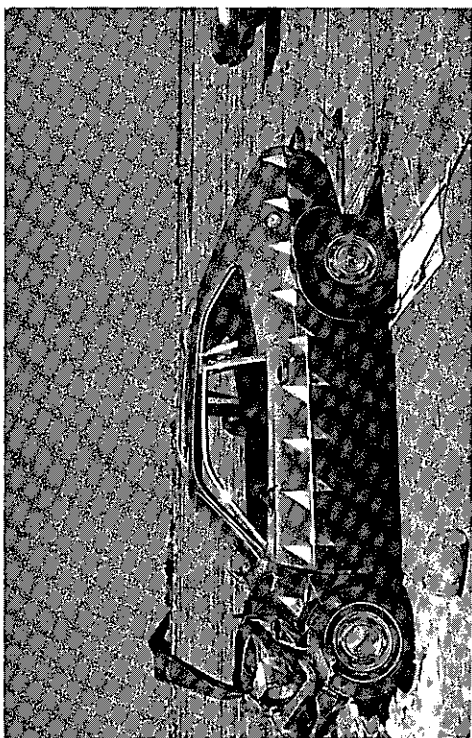
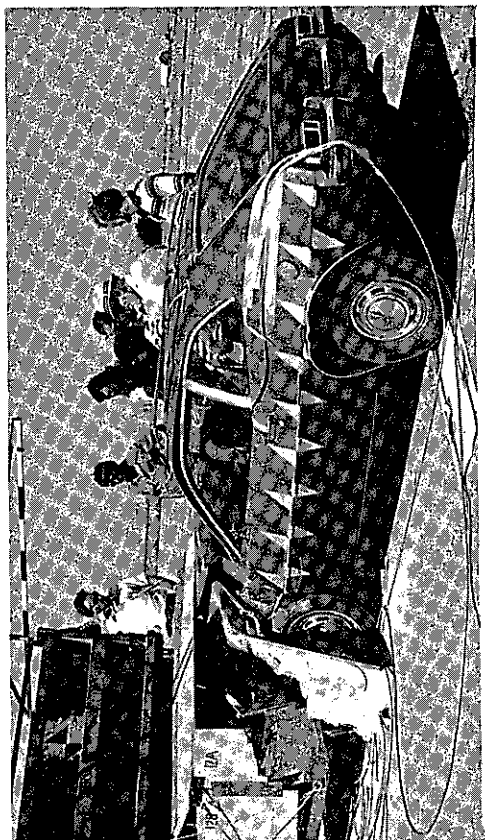
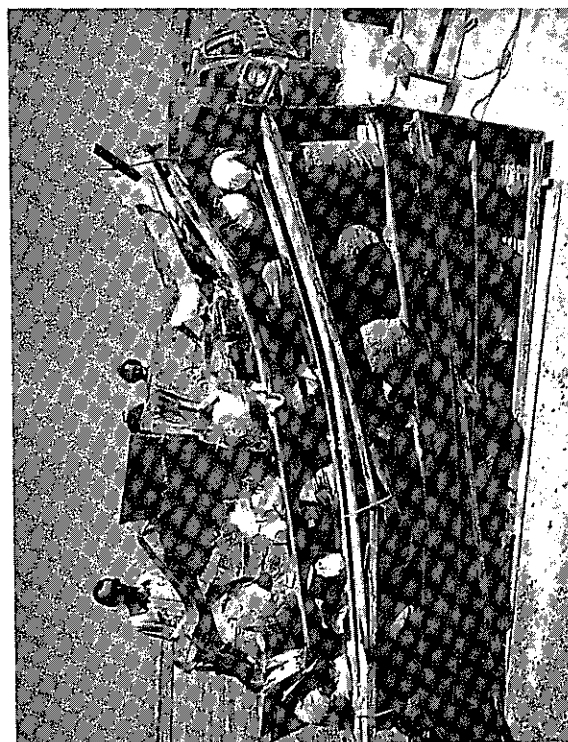
Figure 19. Test EAS-1. Test vehicles and TMA after impact. Bottom photos show top and bottom of TMA which was placed on end.

Damage to the car was quite severe. The front end was crushed back a maximum of 24 inches on one side (about 15 inches at the centerline) at a height of 20 inches above ground. The radiator was crushed, and the engine moved back toward the passenger compartment roughly two inches. The windshield was cracked by the hood, the doors were jammed, and the roof over the door posts was crimped. The tires were intact but were restricted from movement so that the car could not be rolled easily away from its resting place. Some plywood pieces were embedded in the crushed front end of the car, but there was no intrusion of vehicle or barrier parts into the passenger compartment of the car. The lower portion of the steering column moved down enough that it pivoted about a support, thus, breaking the dash.

It appeared that all of the energy absorbing length of the TMA was used up. All vermiculite concrete cells were partially or totally crushed. Permanent maximum crush of the cell-filled box was 37-39 inches top and bottom; however, the box components had some rebound after impact. Therefore, maximum dynamic penetration was greater. The steel grid-work supporting the TMA box had a permanent maximum crush of close to 18 inches. As usual there was a small amount of debris from the TMA scattered around the impact area. There was no damage to the TMA controls on the truck or the TMA steel plate backup structure.

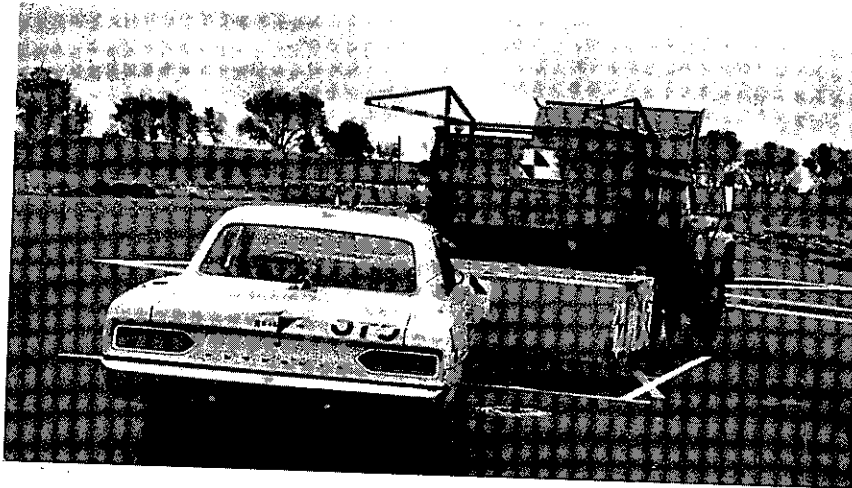
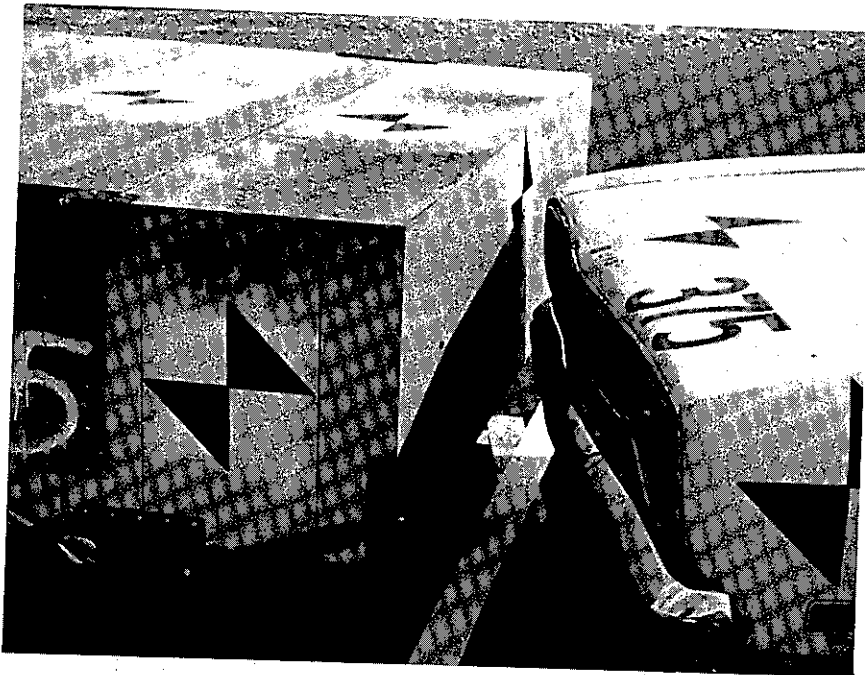
Figure 22. Test 375. Test vehicles and TMA after impact. Lower left: View of crushed cells with plywood cover removed from TMA. Upper and lower right: Final location of car after impact.

The radiator was crushed, the windshield was broken, but the engine did not move rearward. The right front door was jammed, and the roof over the doorposts was crimped. The tires were intact but the front wheels were restricted from movement. The car could not have been driven or rolled away from the impact site.
